EcoCheck, Inc

RE: Wastewater System Assessment for Your Development
Your Town, Minnesota

EcoCheck met with your operation staff on April 20 and 21 to assess the wastewater treatment system designed for the townhomes in your development (Units A, B D and F). The system was designed for a flow of 6,840 gallons in 1996 by Engineering Firm A. Your current operations staff informed EcoCheck of past issues with the frozen or cracked supply and return lines, biological build-up inside the drip irrigation emitters and other operational issues.

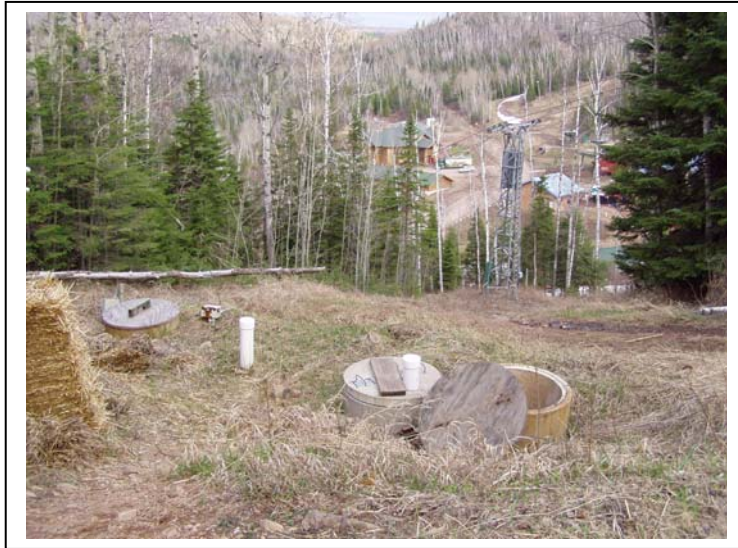
Figure 1: Settling tank on top of hill for the drip irrigation system.

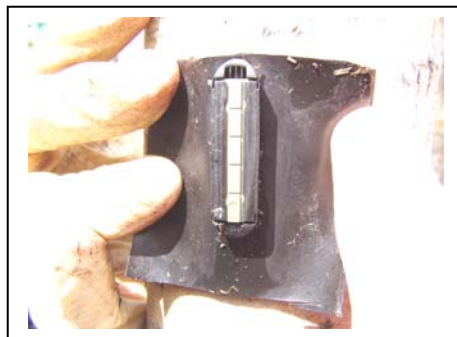
Figure 2 – Drip irrigation emitter without bacterial growth.

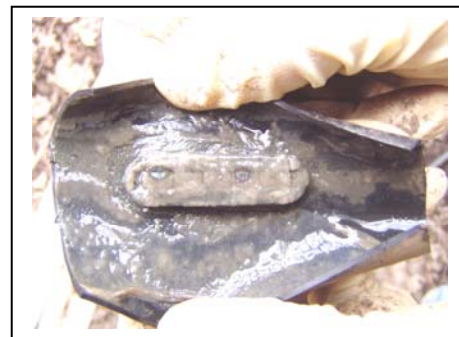
Some of the suspect emitters were cut out to observe the internal condition of the tubing. We found that some of the emitters that were not discharging water had significant biological growth on the emitter, while operating emitters had significantly less biological growth. Based upon observation, the problem emitters may be plugged due to a pressure drop towards the end of the tubing runs causing a decrease in scour velocity (the ability of the water pressure to clean the inside of the pipe). Another possible explanation is that the tubing cannot drain back to the supply or header lines and the effluent remains trapped in the tubing, causing bacteria to grow.

Noting that approximately 10-15% of the emitters were experiencing a plugging condition, EcoCheck prepared an approximate 50 parts per million (ppm) solution of 6% sodium hypochlorite (Chlorox) in the pumping chamber of the settling tank. This was completed to attempt to “shock” the bacterial growth that had been occurring on the outside of the emitters and causing reduced or plugged orifices (see Figures 1 and 2).

Figure 3 – Drip irrigation emitter with extensive bacterial growth, plugging the emitter.

Recommendation – Periodic application of sodium hypochlorite should be completed during times of low flow activity. We recommend operations staff to perform this 1-2 times a year. If orifices are plugged, they should be removed and inspected to determine the cause of the plugging (i.e. biological growth, dirt, sand or other obstruction). Please consult EcoCheck on sodium hypochlorite dilution rates.

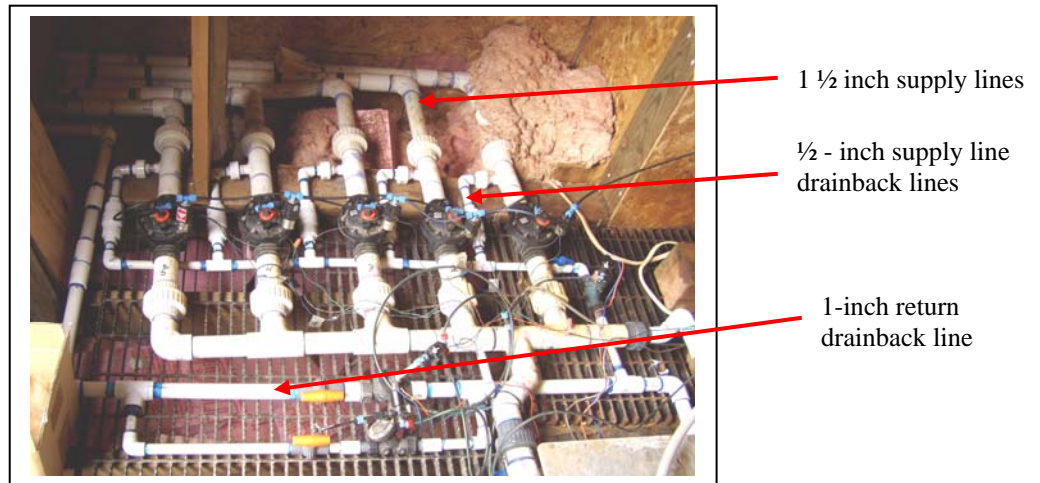
- b. The supply and return lines in the drip zones have a larger pipe diameter than at the drainback line (where all water in the system drains back to the settling tank). Both supply and return lines are 1-1/2 inches in diameter, yet when the lines connect near the control building, the supply line drainback is ½-inch diameter and the return line pipe diameter is reduced to 1-inch.

Figure 4: Supply and return line pipe diameters.

- c. In drip irrigation systems, it is important to drain the supply and return lines quickly to prevent the potential for line freezing. The current situation slows the drainback process and increases the freezing potential. This may be part of the reason why supply and header lines have become broken in the past.

Recommendation – To minimize freezing, EcoCheck believes the piping inside the control building should be modified to a larger diameter pipe (i.e. 3-4 inch in diameter). This should improve drainback time. Further, we believe an operational change should occur by not manually shutting off the valves outside of winter if plugging is occurring in the return lines (which can be confirmed by operational staff).

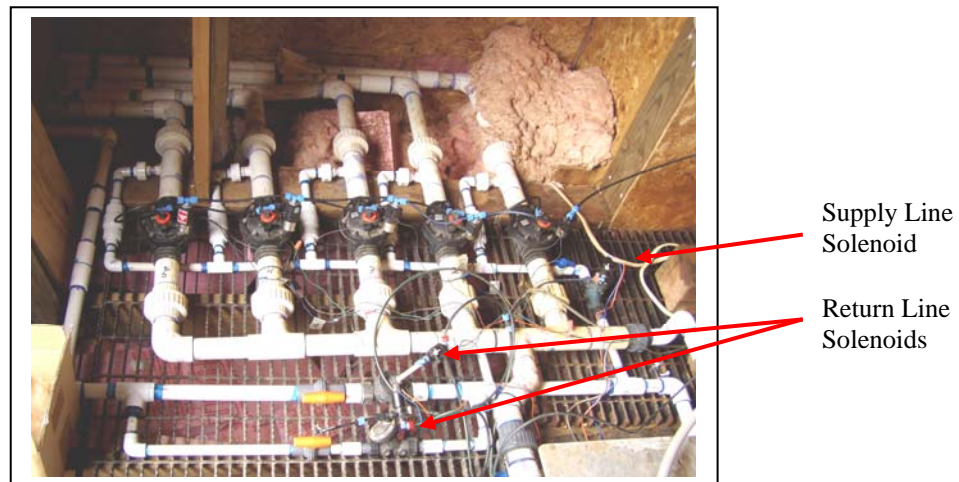
4. **Solenoid Operation** – It is difficult to tell whether the solenoid valves are opening or closing based upon the PLC logic. We attempted to do this, however in manual pumping mode, the solenoids do not operate unless the valves are opened in automatic mode by the PLC logic. Based upon observation during automatic operation, it appears the drainback valves are not opening or closing as they should be. When the pumps turn on, the supply and return valves should close (when not in flushing mode) and should open when the pumps turn off to allow for drainback. An output light is located on the PLC which does not light up when the valves open or close. Because of this, we believe the PLC is not communicating with the drainback solenoid valves.

Figure 5: Head works of Zones 1-5 and supply and return lines.

Recommendation – An electrician should look at the PLC outputs and confirm solenoid operation for the supply and return lines.

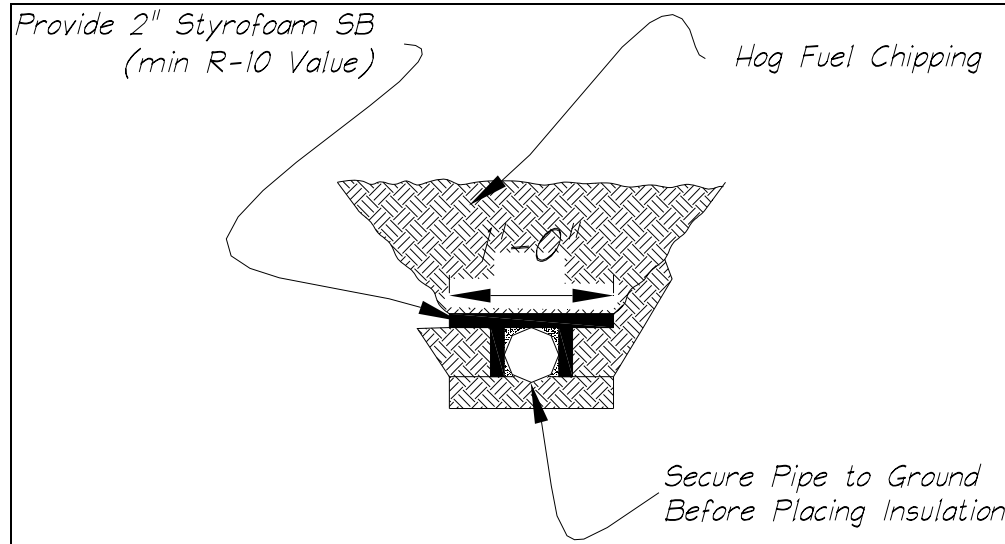
7. **Insulating Supply and Return Lines** – Several of the supply and return lines are exposed to the open environment and have not been buried. The operators have described issues with repairing pipe breaks in the supply and return lines. The broken lines may be occurring from recurring fill and drain cycles, causing ice sheeting on the inside of the pipes. This is the likely scenario since pipe breaks have occurred in areas that appeared to have adequate slope for drainback.

Recommendation – The supply and return lines should be secured to the ground by a U-Clamp, if it is lying on top of the ground. To minimize freezing potential, the operator should provide box insulation (as shown in the figure below) of all of the exposed pipe and cover the insulation with hogfuel.
